Impacts of Upstream Disturbances on Downstream Sediment Yield and Morphology in the Presence of Best Management Practices

Ilkim Cavus

Auburn University, School of Forestry and Wildlife Sciences

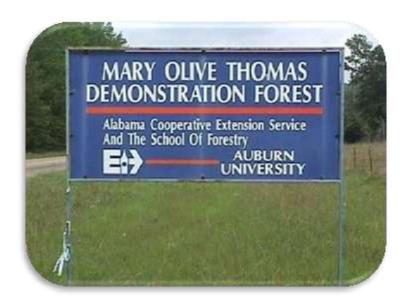
STUDY AREA

- > South Auburn
- Managed by SFWS, Auburn University
- ➤ Average annual rainfall: ~148cm
- ➤ Average slope: <6 %

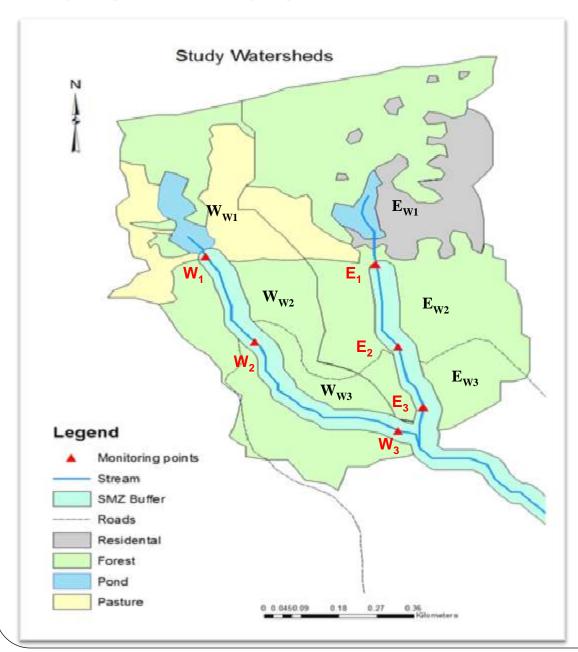
- ➤ Land use/Land cover
- > 6 sub-watersheds
- ➤ 6 monitoring stations
- > SMZs

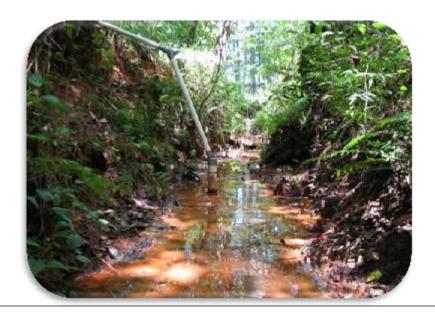
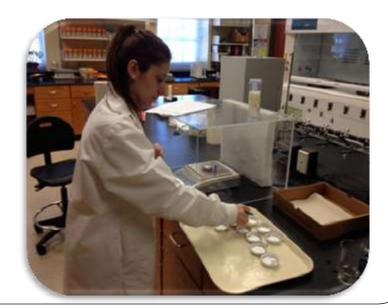
- Sediment and hydrologic sampling
 - Water stage measurements using pressure transducers
 - Standard stream cross-sectional velocity profile
 - Rating curves
 - Water samples
 - The 2540 Total Suspended Solids Dried Method

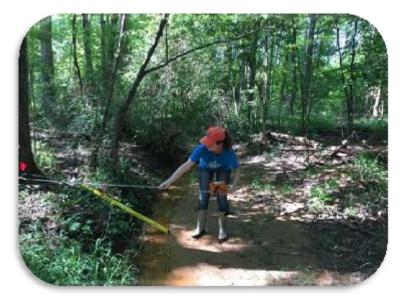
- Stream morphology
 - Stream cross section/transect surveys
 - Bankfull cross sectional area
 - Width/depth ratio, Entrenchment ratio
 - Pebble Count
 - Rosgen stream types

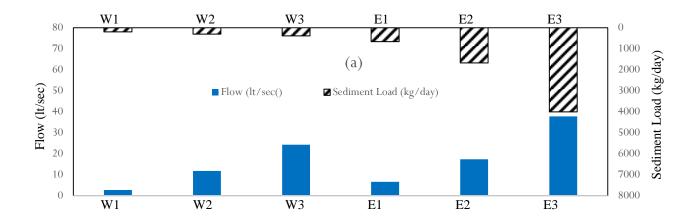
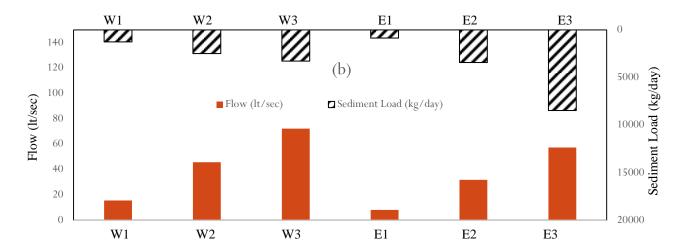
Discharge and sediment load in both W_W and E_W during the event of 2/21/2014 (a) and 4/19/2014 (b)

- > End of upstream disturbances
- > Decreasing trend in sediment movement to downstream

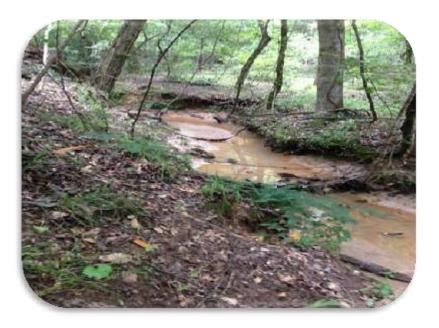
- West Stream
 - Width depth ratio<12
 - Entrenchment ratio >2.2
 - **■** Sinuosity = 1.6
 - Water surface slope = 0.018
 - E5 stream type

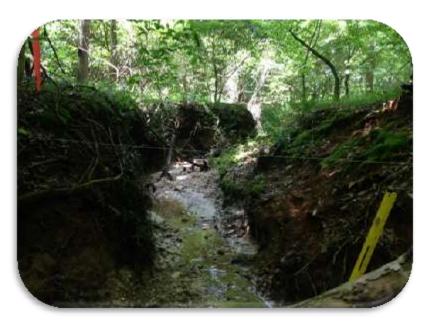
- East Stream
 - Width depth ratio>12
 - Entrenchment ratio < 1.4
 - Sinuosity = 1.3
 - Water surface slope = 0.014
 - F5 stream type
