# **Watershed Assessment Of The Big Canoe Creek System For The Recovery And Restoration Of Imperiled Aquatic Species**

**Anne Wynn  
Geological Survey of Alabama  
Ecosystems Investigations Program**

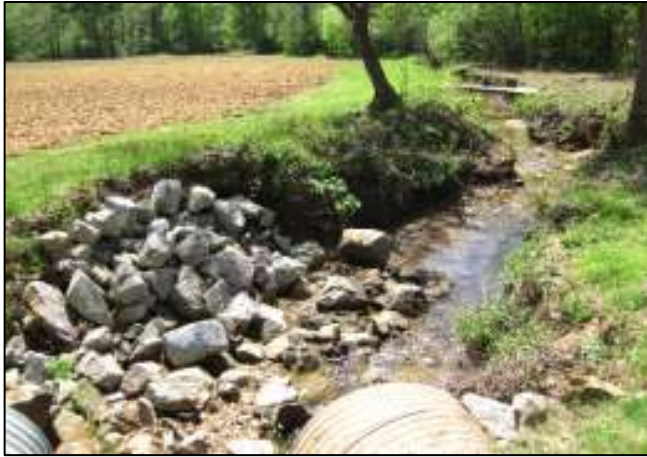
**Channel and bank erosion**

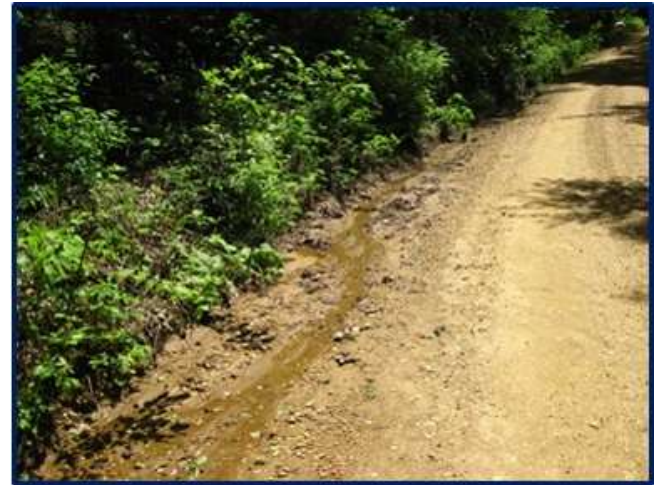
**Steep road approaches**

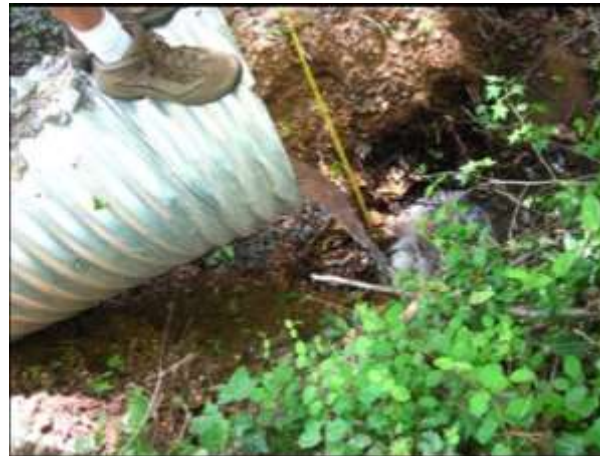
**Poor crossing fill condition**

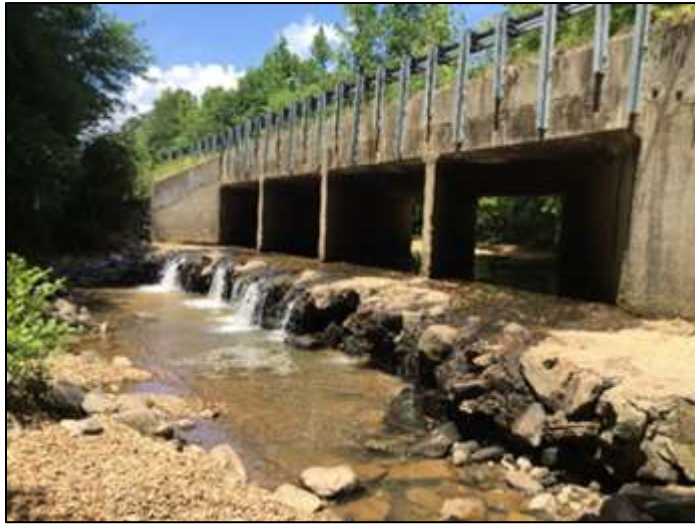
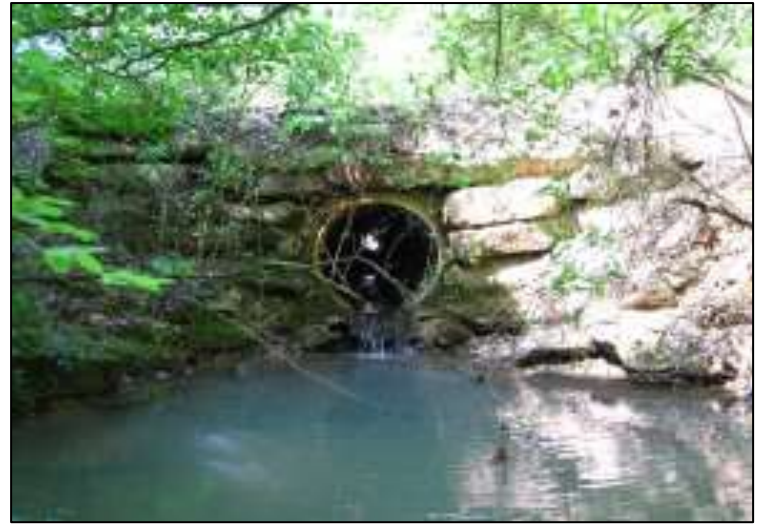
**Fish barriers were also recorded during the SRI surveys and stream reaches blocked by small dams or perched crossing structures were documented. The 20 sites with fish barriers will be evaluated for restoration.**
